North Coast Regional Water Quality Control Board

Report of March 25, 2021 Warrant Inspection of Humboldt County Assessor's Parcel Number (APN): 208-281-032-000

File: Cannabis Program Inspections, Humboldt County, 2021,
CIWQS Place ID: 829092

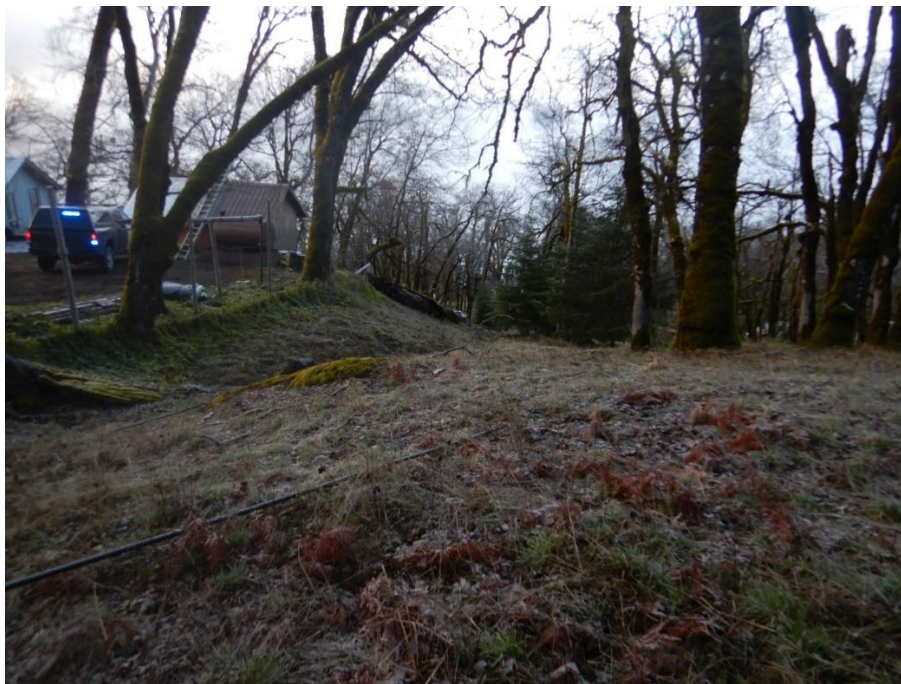
Photo 1—Looking south towards spring at WQ 1.

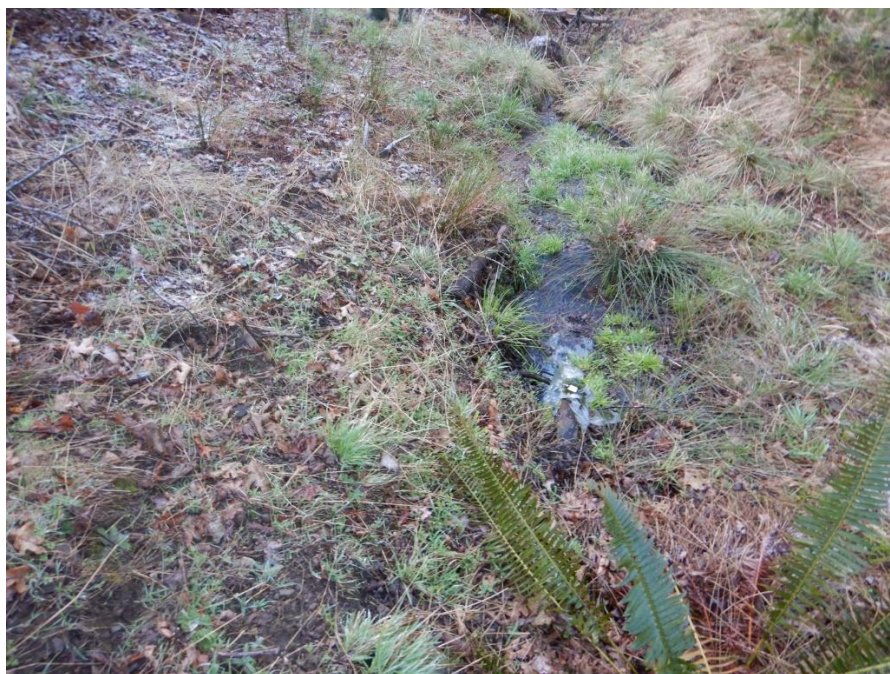
Photo 2—Looking south at spring discharging into the head of a watercourse located at WQ 1.

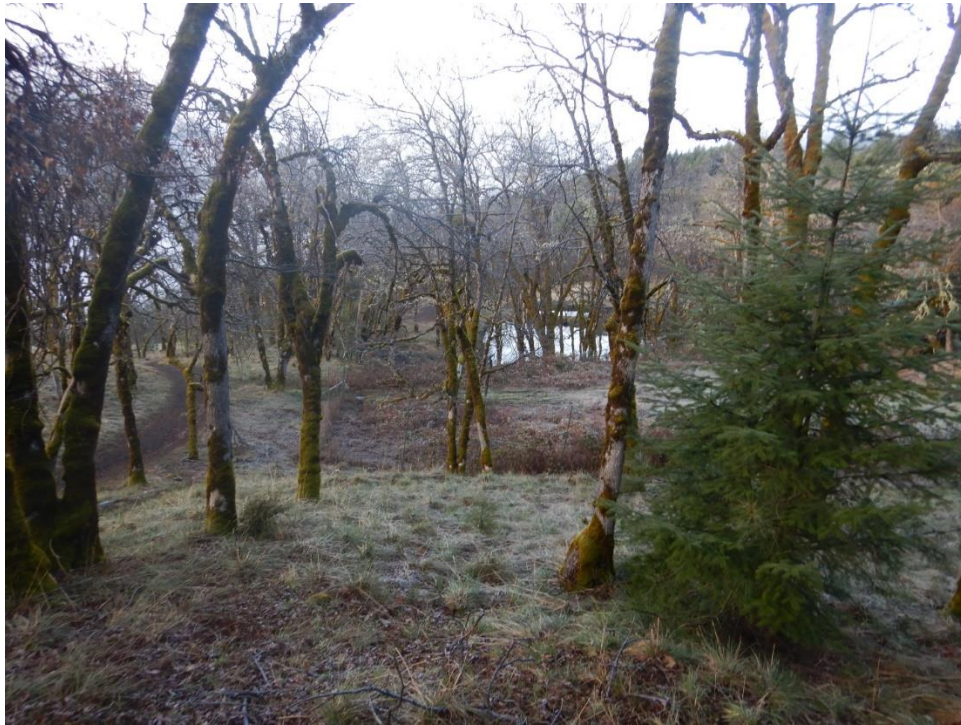
Photo 3—Looking south towards reservoirs located at WQ 2. A historical pad is visible between the spring and the reservoir.

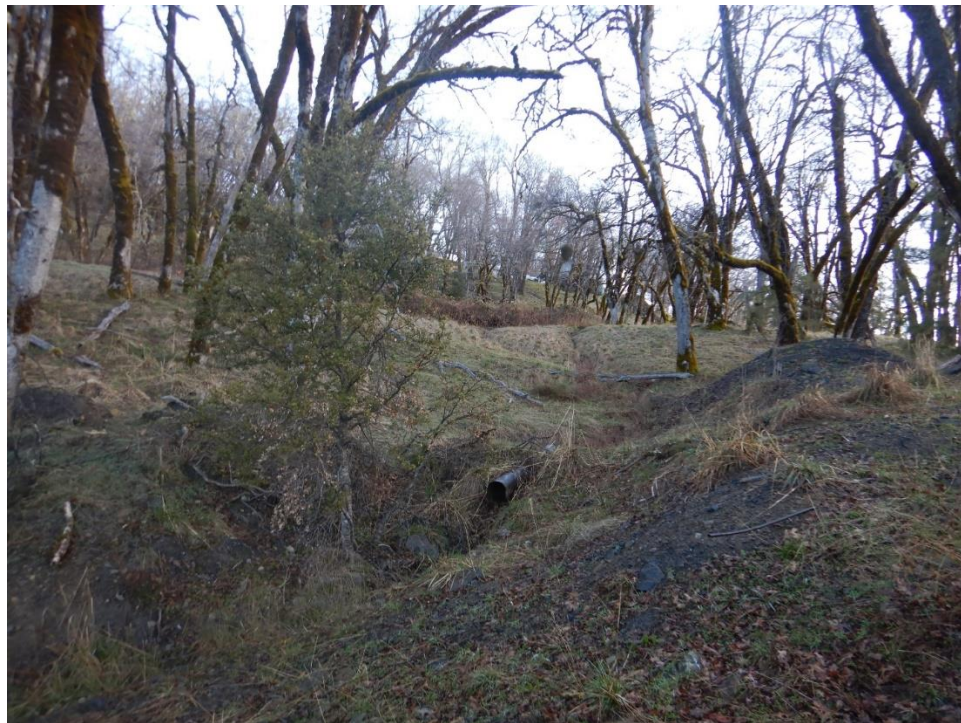
Photo 4—Looking north from reservoir at WQ 2 toward spring at WQ 1. A pipe from below the historical pad discharges into a channel upstream from the reservoir

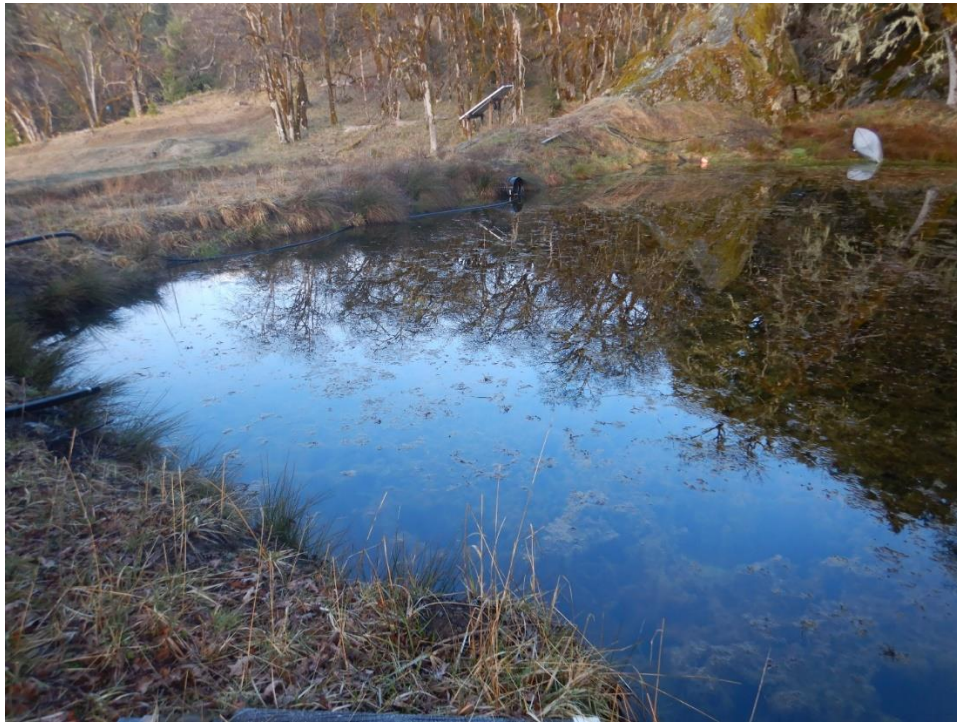
Water is stored in the onstream reservoirs at WQ 3 and in hard-walled storage tanks on the property. I did not observe evidence of instability associated with the reservoirs, however, onstream reservoirs impact many Beneficial Uses of receiving waters.

Photo 5—Looking west across upper level reservoir towards the eastern berm at WQ 3. A pipe connecting the upper reservoir to a lower reservoir is visible in the top center of the image.

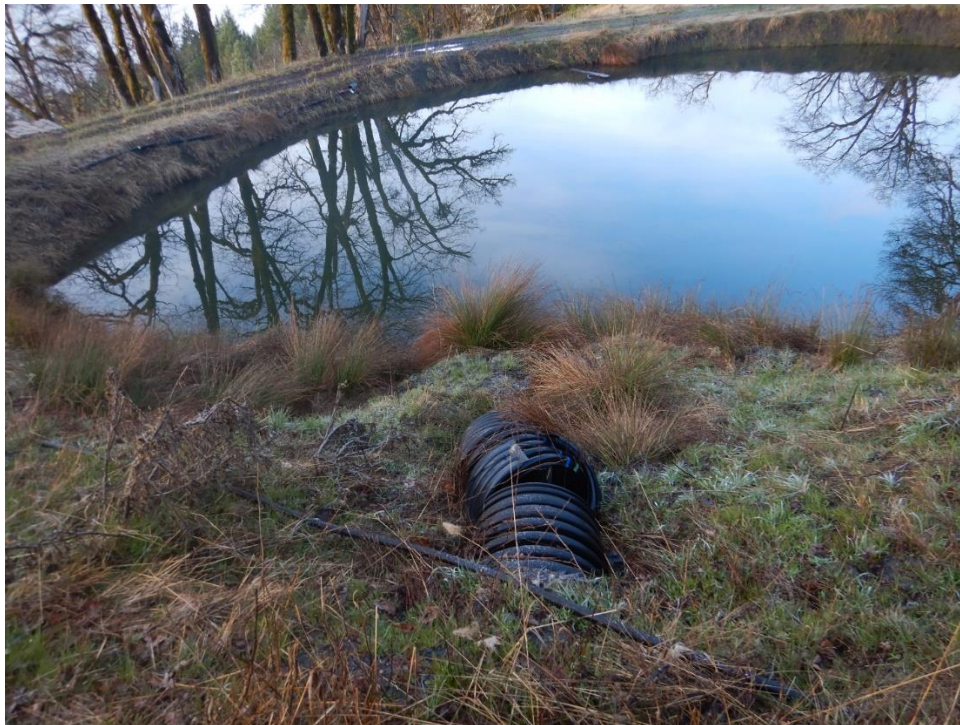
Photo 6—Looking southwest towards the lower reservoir from the berm separating the two reservoirs at WQ 3.

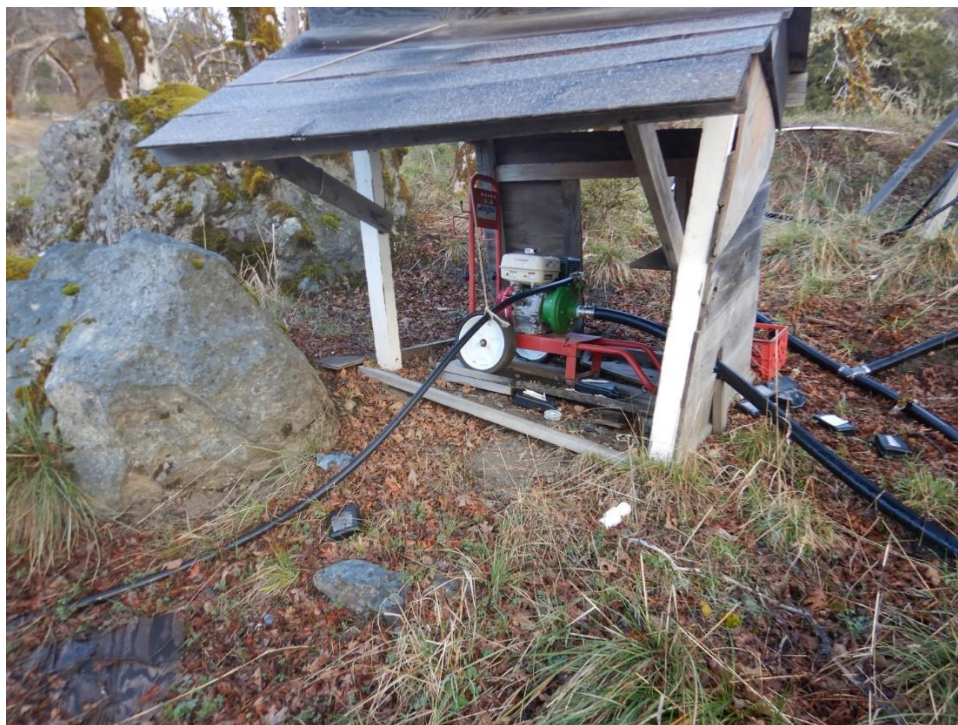
Staff observed waste oil containers uncontained on the ground at WQ 4, and fuel cans stored covered without secondary containment at WQ 1.

Photo 7—Looking north at pump located at WQ 4. Used oil containers are uncontained on bare ground.

6. Store and contain all chemicals, including petroleum, fertilizer and/or pesticides properly to prevent spillage and discharge to receiving waters. Provide secondary containment for all petroleum products.

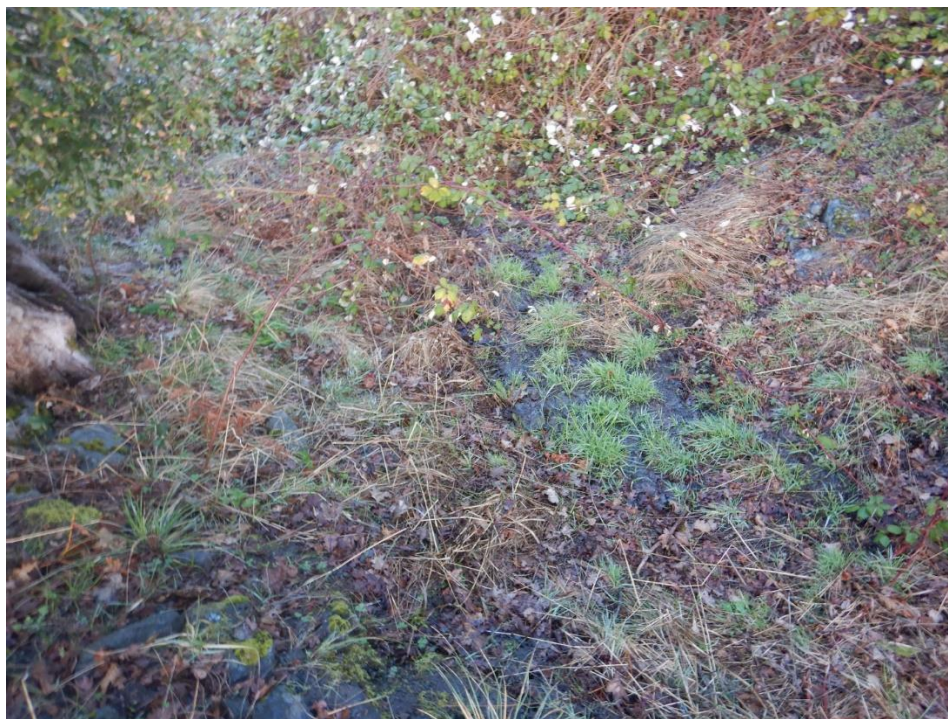
Photo 8—Water emanating from the ground in the vicinity of WQ 4. The water flows south to a watercourse crossing a road through a culvert at WQ 5.

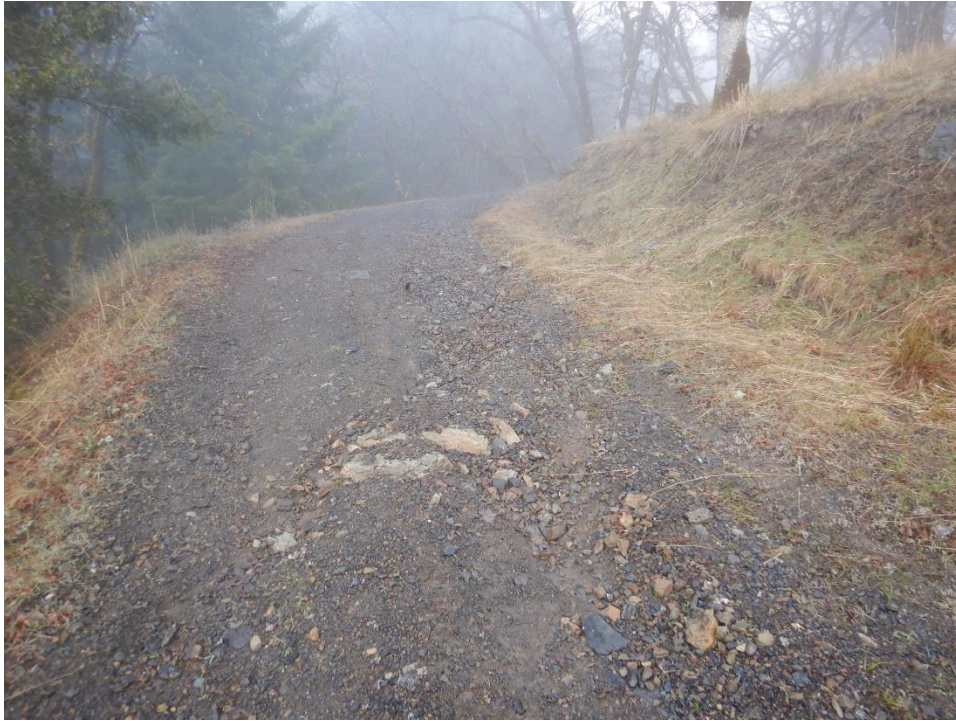
Photo 9—Looking west along a road west of WQ 5. Stormwater concentrating on road surface has exposed a coarse aggregate of rock.

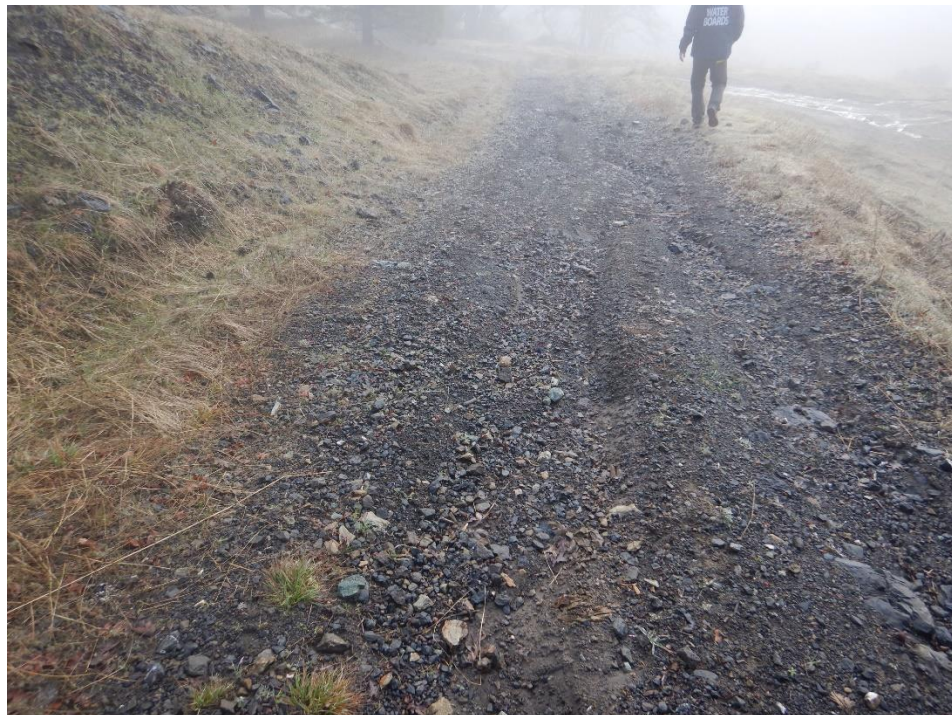
Photo 10— Looking east along a road west of WQ 5. Stormwater concentrating on road surface has exposed a coarse aggregate of rock.

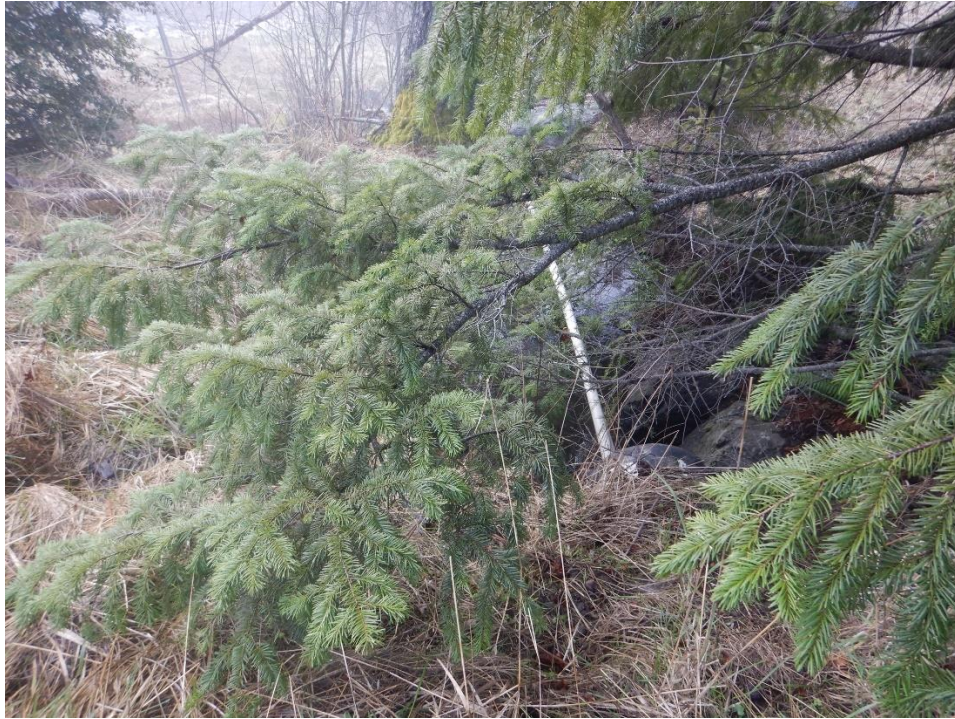
The crossing at WQ 5 may not be adequately sized and should be assessed by a qualified professional. The crossing at WQ 6 is buried at the outlet.

Photo 11—Looking south at culvert outlet located at WQ 5. The channel is obscured by vegetation, small boulders are visible armoring the channel at the outlet.

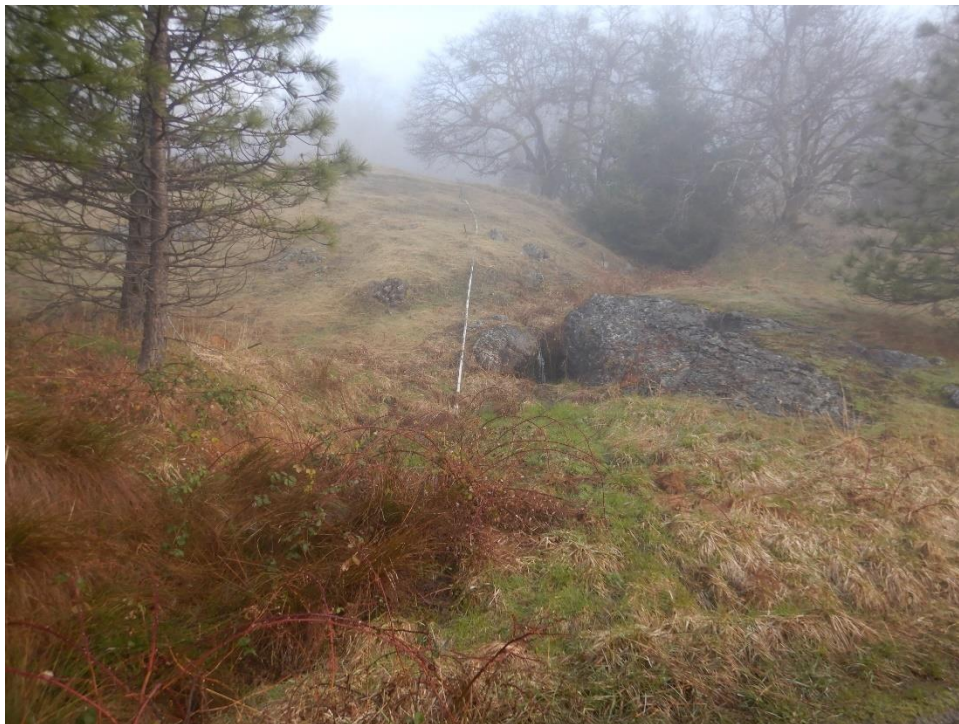
Photo 12—Looking north upstream from WQ 5.

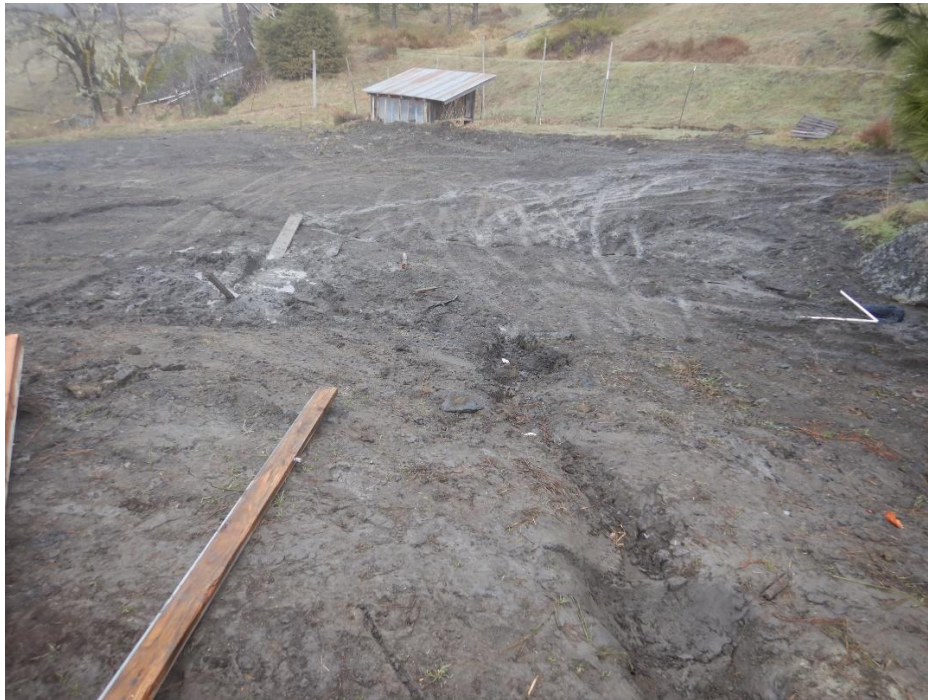
Trenches in the greenhouse at WQ 7 connect the greenhouse to the neighboring watercourse to the west, allowing irrigation runoff to reach receiving waters.

Photo 13—Looking west at location of former onstream reservoir. The photographer is standing on a greenhouse pad with the greenhouse to their back. A trench draining the greenhouse is visible in the lower right of the image and connects to the reestablishing watercourse in the center of the image.

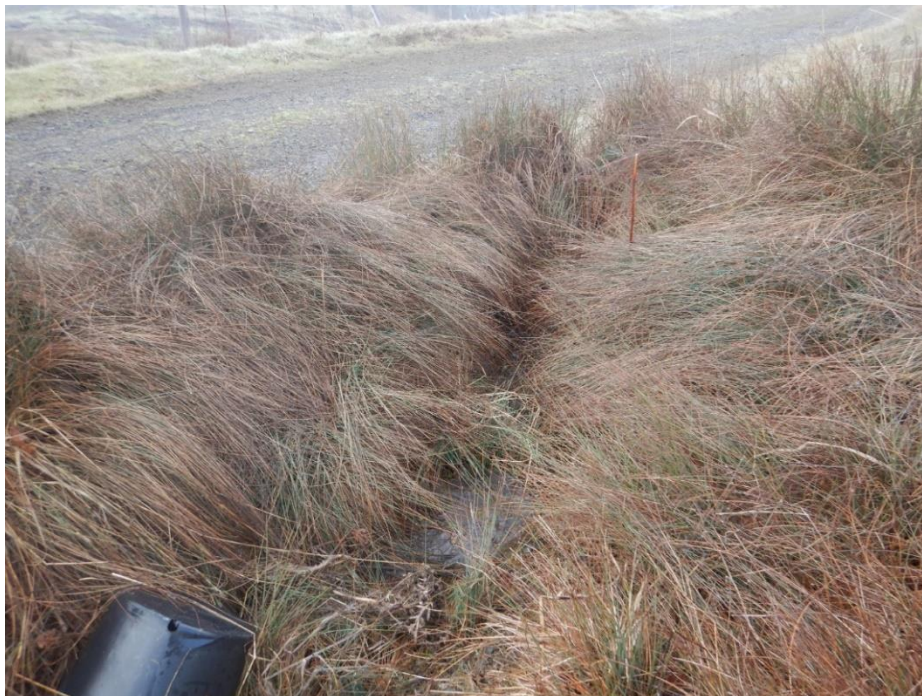
Photo 14—Looking south at a spring located at WQ 6. Springwater passes below the road through a culvert with a buried outlet.

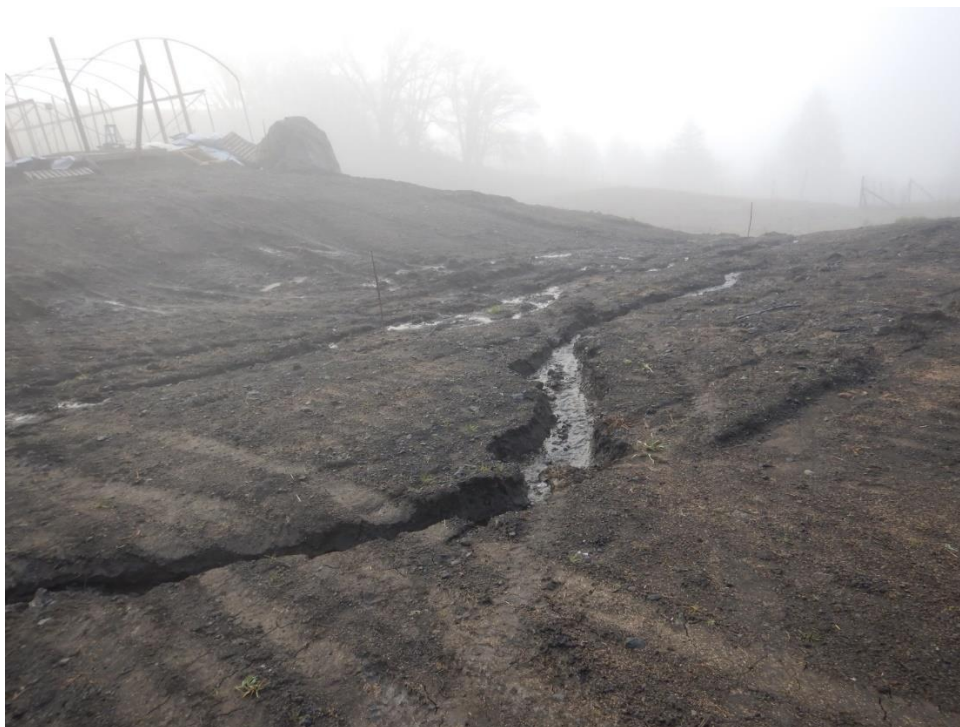
This report does not cover the roads accessing the property from the east. The roads northwest of WQ 5 display rills from concentrated stormwater, but the aggregate is coarse. The disturbed area where the reservoir was removed south of WQ 6 has significantly impacted a watercourse and continues to threaten discharge of fine sediment to receiving waters. The graded area associated with the cultivation area at

Photo 15—Looking south at the graded area downstream from the spring at WQ 6.

3. Retain a licensed professional to develop a work plan to restore the segment of watercourse between WQ 6 and WQ 7.
4. Prior to conducting any instream work associated with recommendation 3, above, submit to the Regional Water Board an application for Clean Water Act section 401 water quality certification, and secure approval from the Regional Water Board.

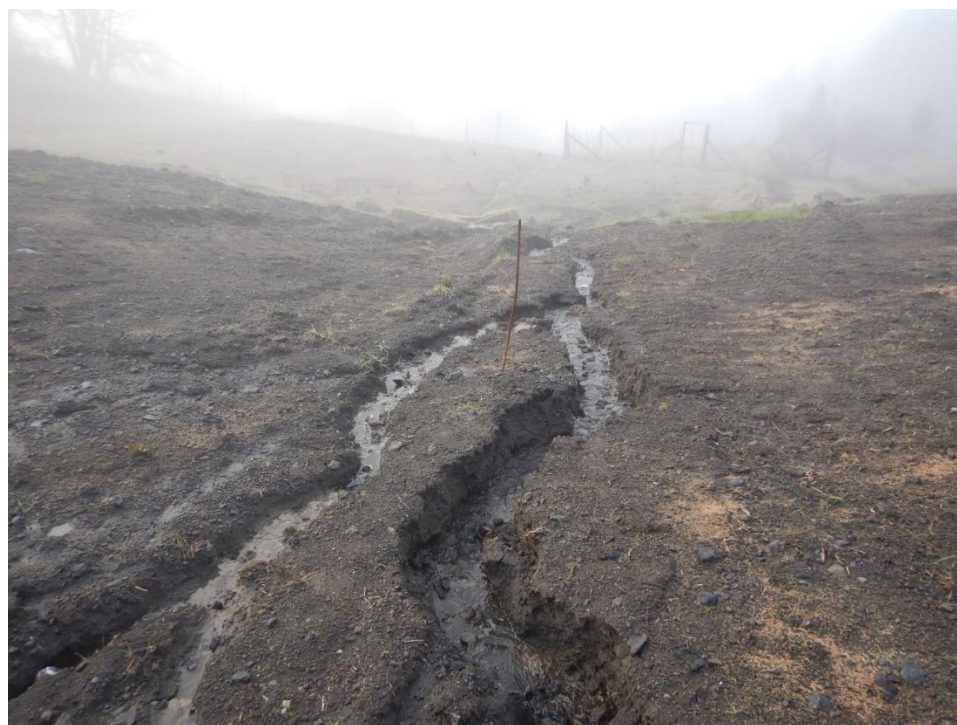
Photo 16— Looking south at the graded area downstream from the spring at WQ 6. This picture is farther south and downstream from the previous image.

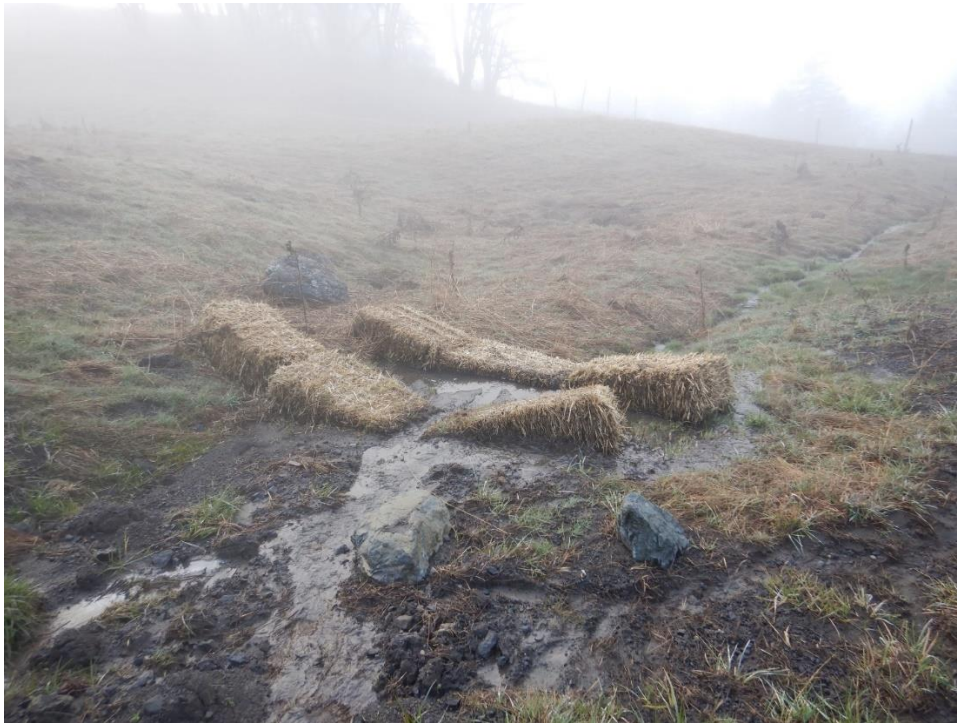
Photo 17—Looking south at haybales separating graded area from receiving watercourse located at WQ 7. This picture is farther south and downstream from the previous image.

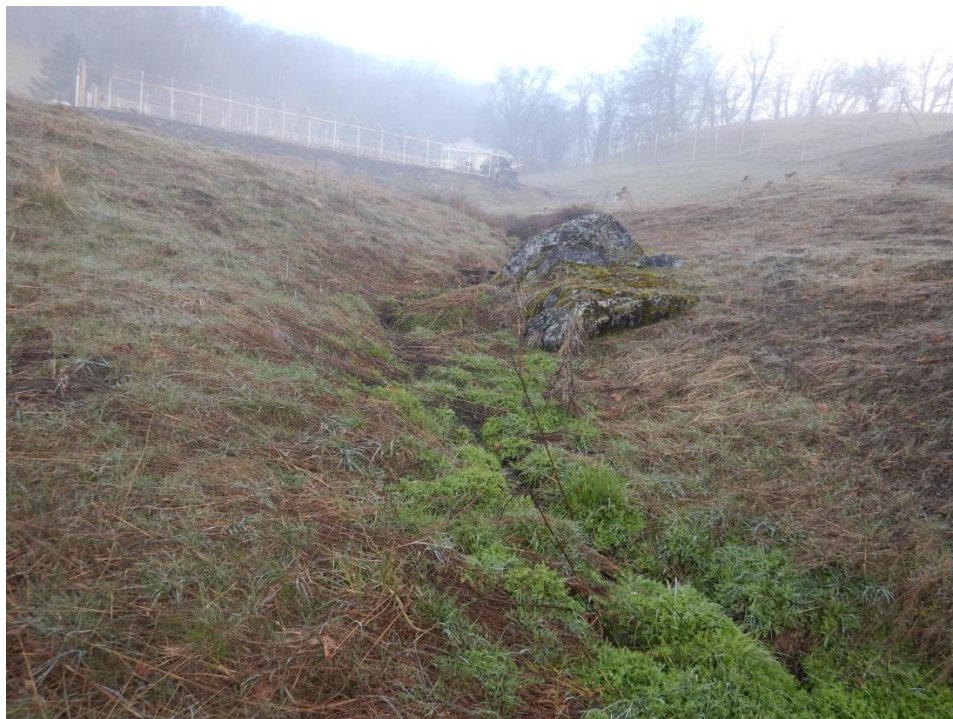
Photo 18—Looking north towards greenhouses from watercourse east of WQ 7.

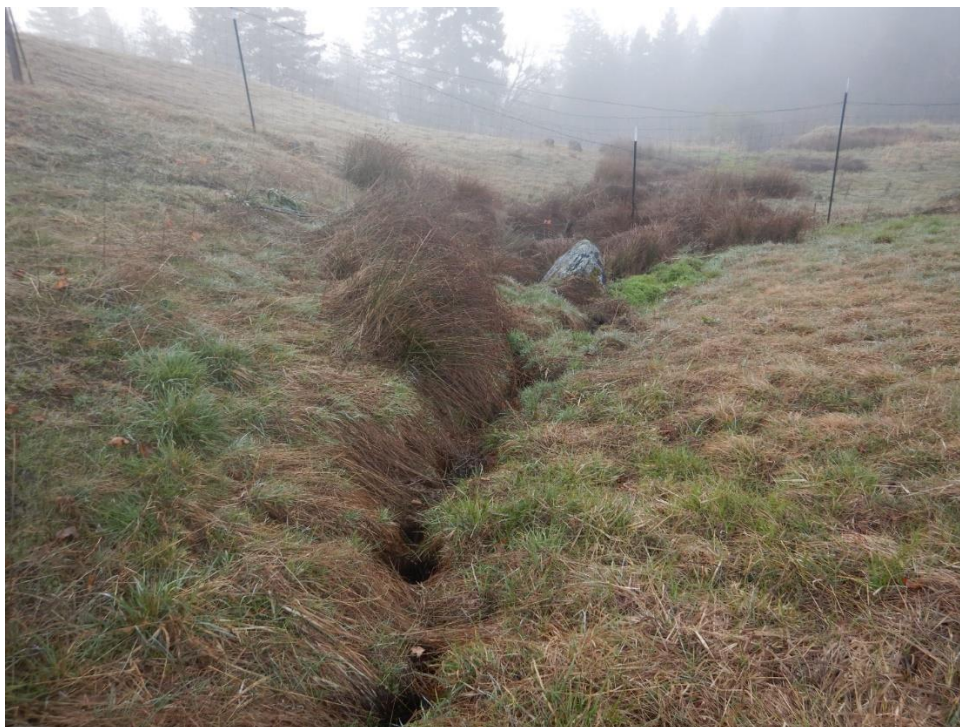
Photo 19—Looking south and downstream along the same watercourse east of WQ 7 that is pictured in the previous image.

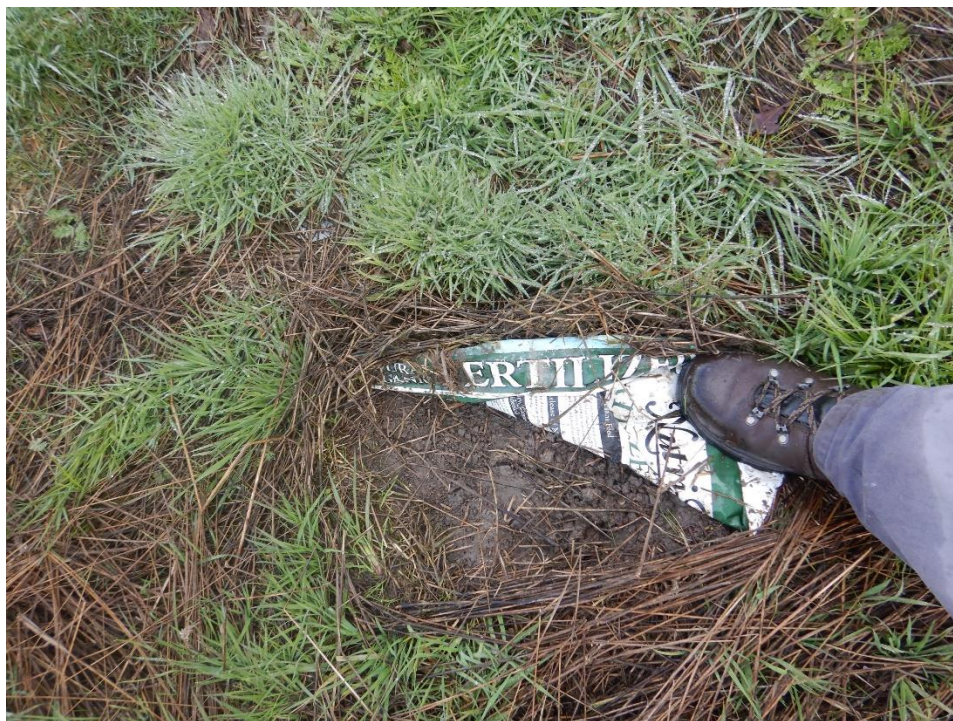
Photo 20—Buried soil bag east of WQ 7.

5. Collect and dispose of or contain all refuse and cultivation-related wastes in a location and manner so as to minimize potential for these wastes to enter or be transported into receiving waters.

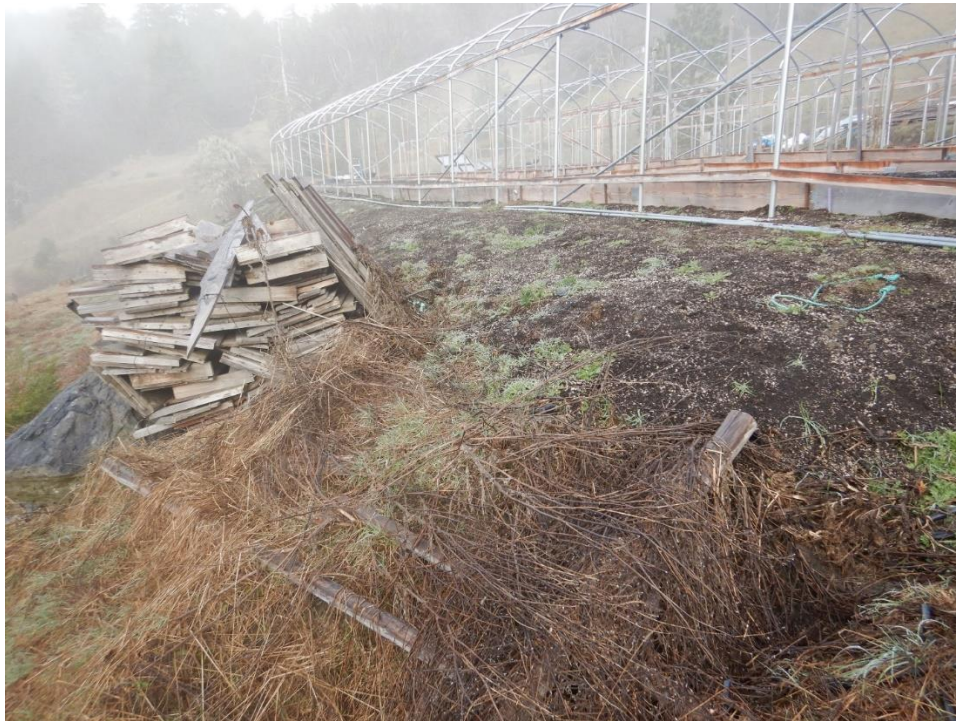
Fertilizers south of the greenhouse east of WQ 7 are uncontained and threaten to spread downslope to receiving waters.

Photo 21—Looking west along the southern edge of the greenhouse located northeast of WQ 7. Note white speckled perlite in the soils along the edge of the greenhouse.

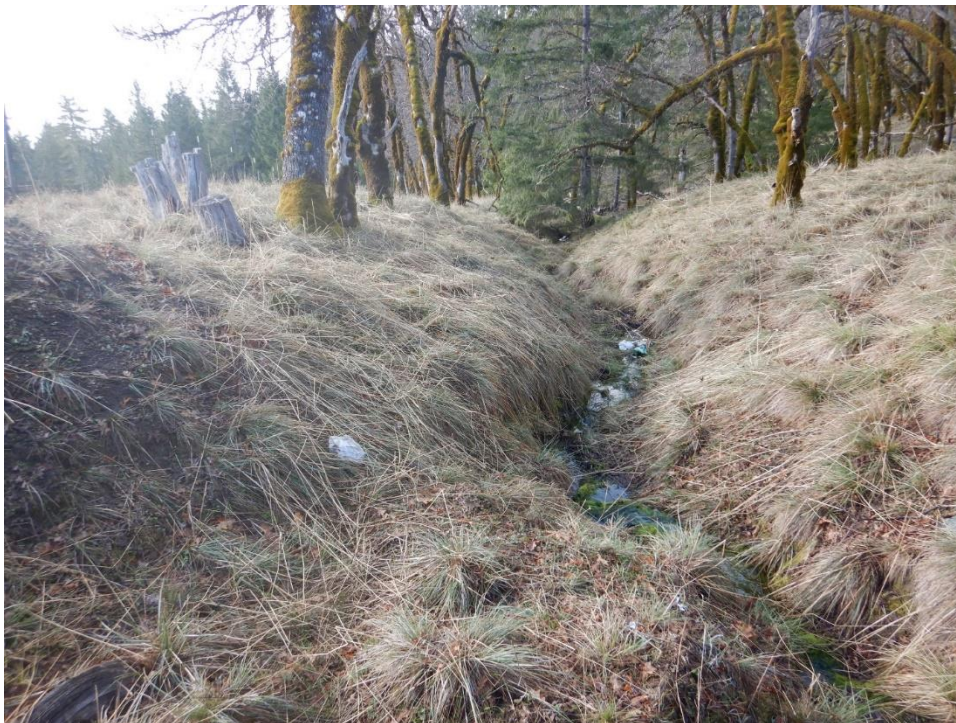
Photo 22—Looking south along watercourse at WQ 8. Note waste soil bag in watercourse near the center of the image.

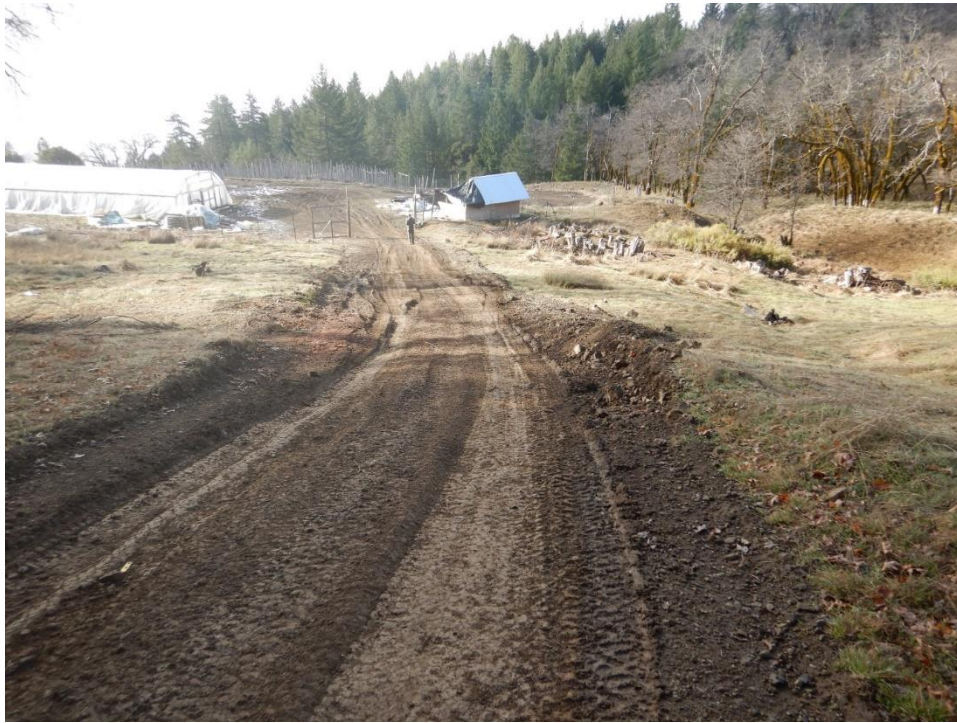
Photo 23—Looking south towards cultivation area at WQ 9. The person to the left of the shed in the top center of the image is standing in the approximate location as the photographer in the following image.

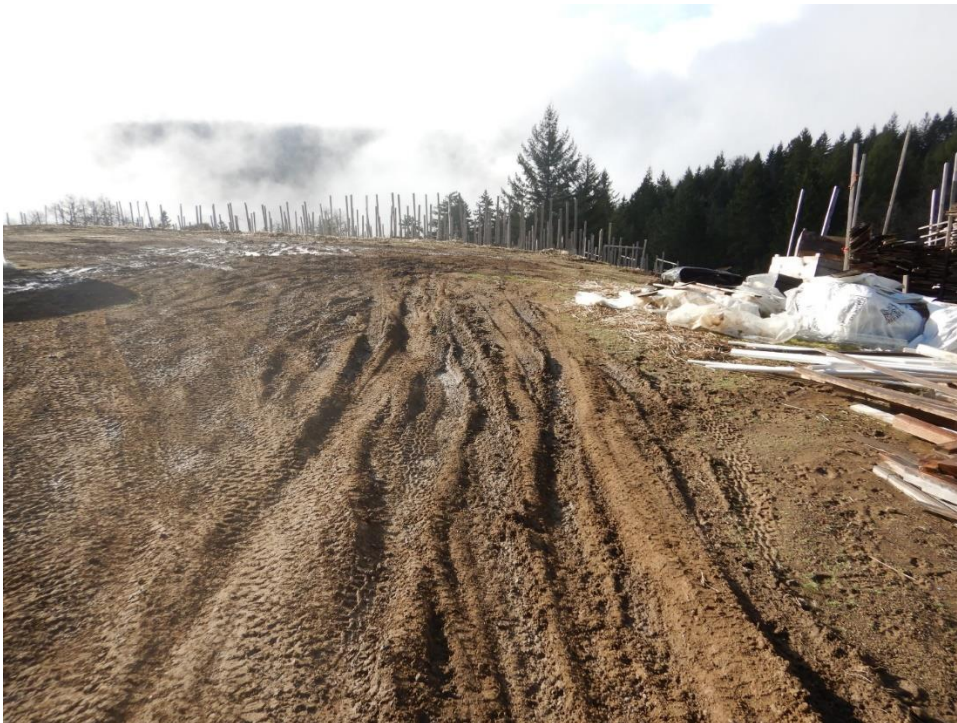
Photo 24—Looking south towards cultivation area in the vicinity of WQ 9.

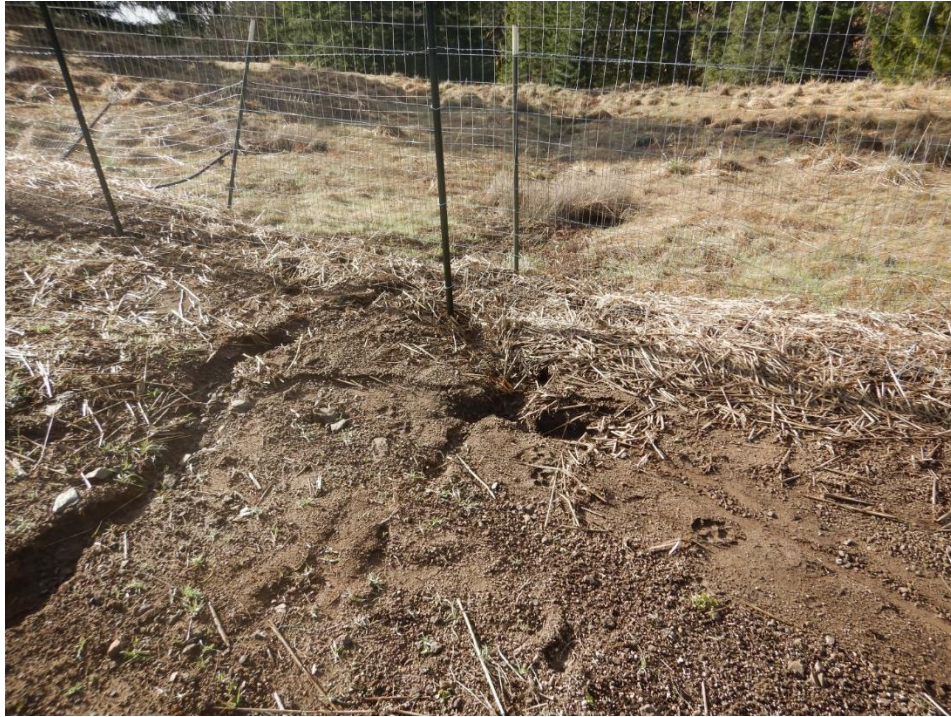
WQ 9 exhibits rills from erosion by stormwater and threatens to discharge sediment laden stormwater to watercourse to the south.

Photo 25—Looking south at rills from stormwater at the southern edge of the disturbed area in the vicinity of WQ 9.

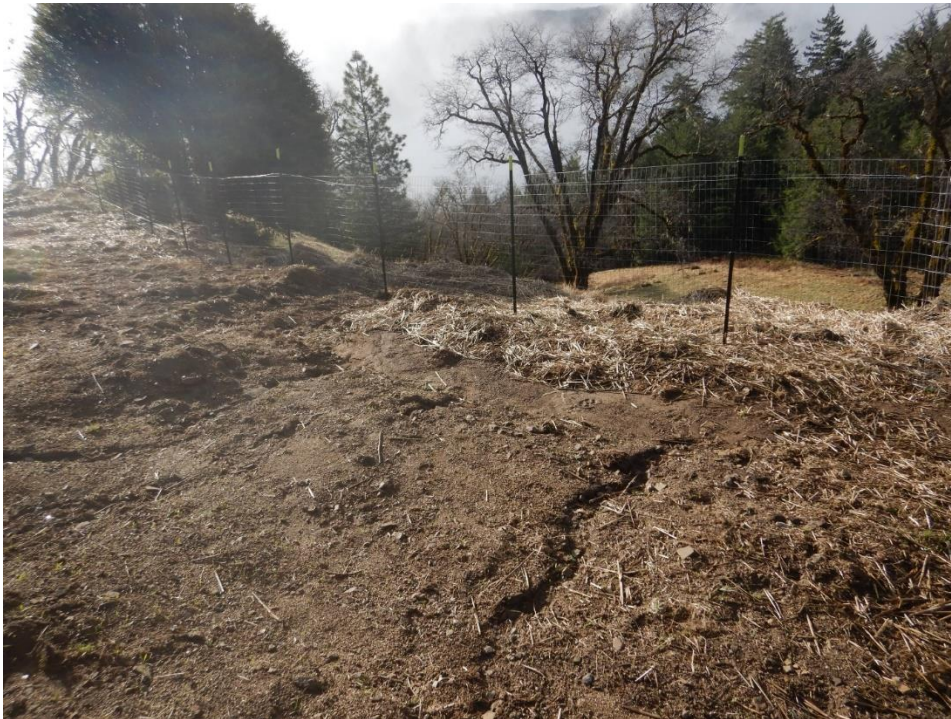
Photo 26— Looking south at rills from stormwater at the southern edge of the disturbed area in the vicinity of WQ 9.

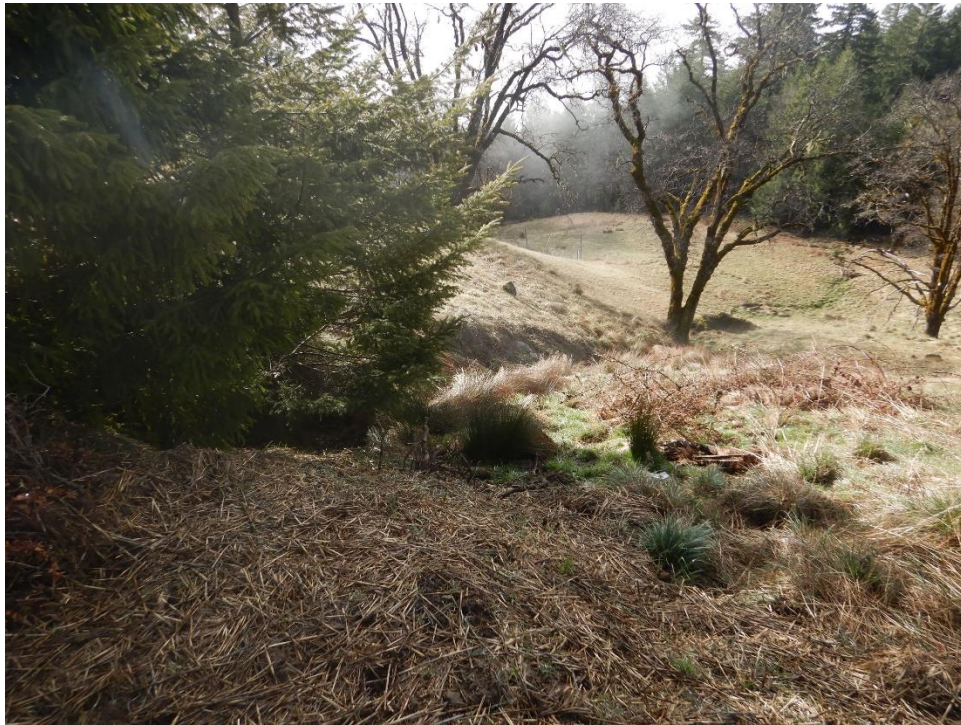
Disturbed area associated with cultivation in the vicinity of WQ 7 overlaps, and discharges to a watercourse. The disturbed area associated with cultivation in the vicinity of WQ 9 abuts and threatens to discharge sediment to a watercourse.

Photo 27—Photo taken at WQ 9, looking south at watercourse. The edge of the disturbed area is immediately to the left of the photographer.

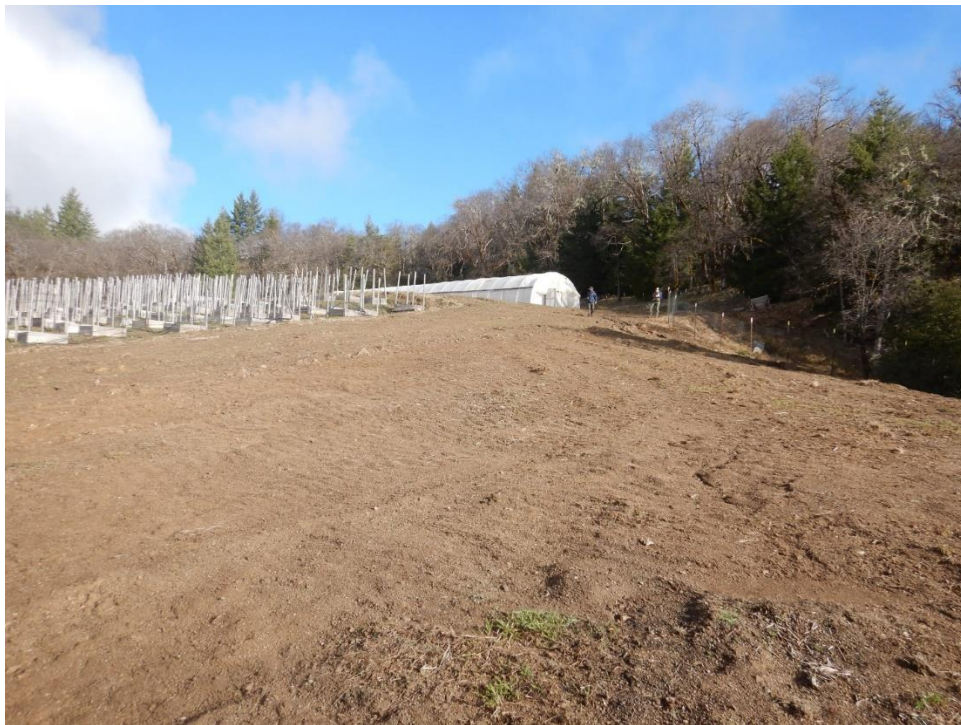
Photo 28— Looking north along the eastern side of the graded area in the vicinity of WQ 9.

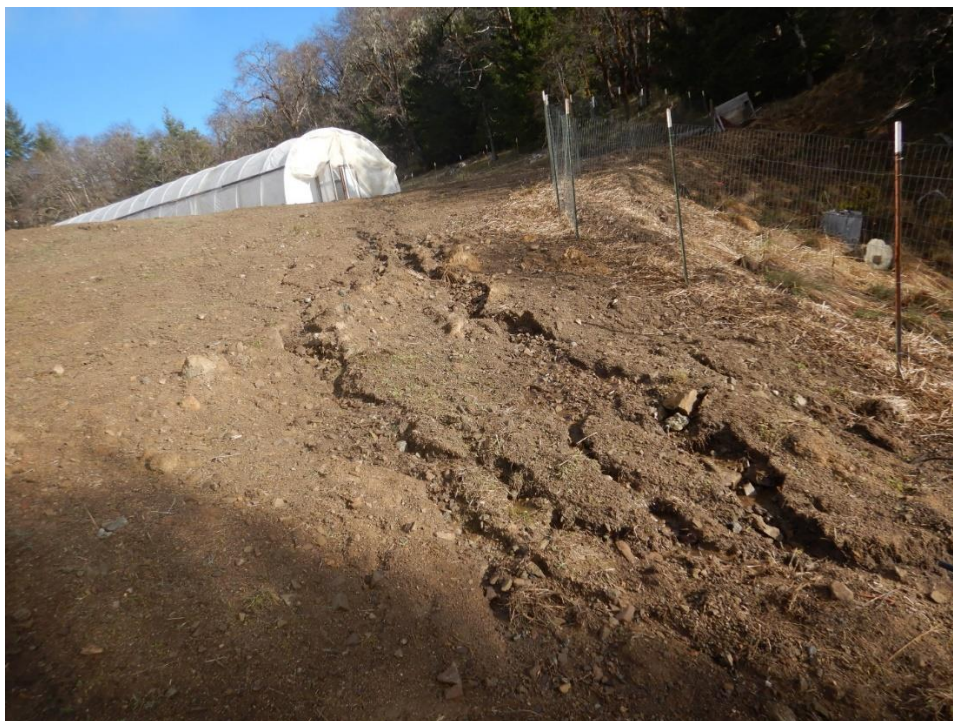
Photo 29— Looking north along the eastern side of the graded area in the vicinity of WQ 9. Note rills formed from stormwater flowing over the graded earth.

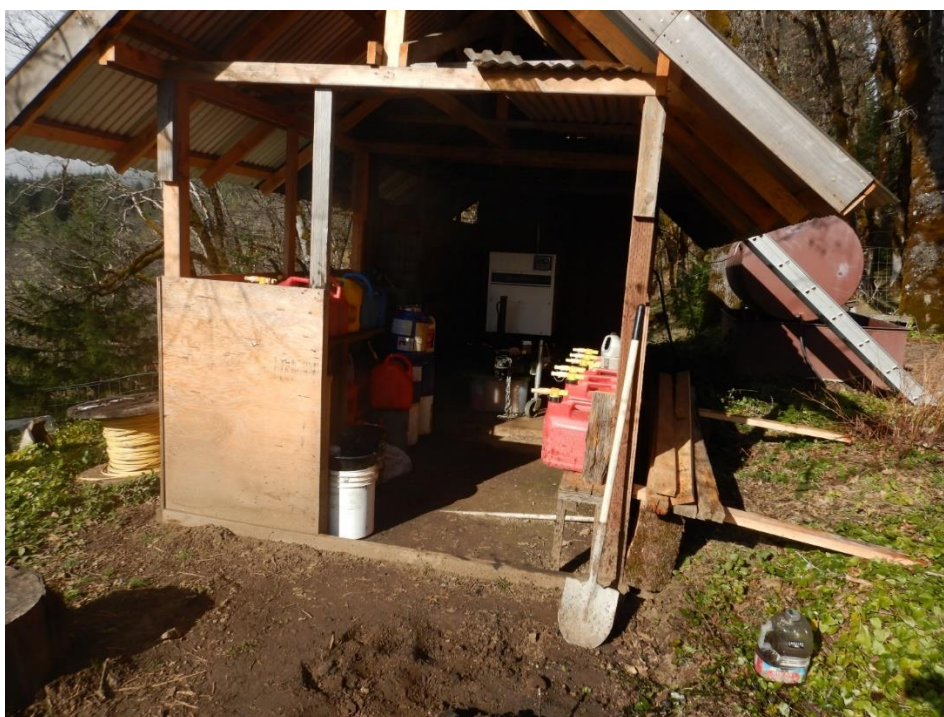
Photo 30—Looking at the fuel storage area north of the house near WQ 1. The shed has an earthen floor with no secondary containment for fuels and chemicals.
